APPLICATION REPORT

Company: CS ENERGY CALLIDE POWER STATION BILOELA

Application: Boiler 2 Unit, Penthouse Refractory Repair

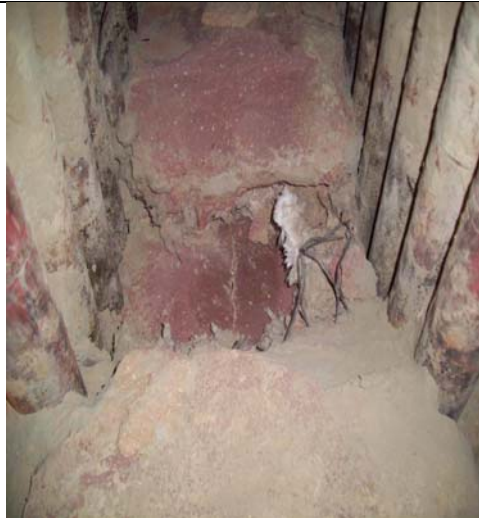
The Boiler penthouse floor was badly eroded. A heavy layer of fly ash dust was removed by vacuum, all loose broken refractory removed before the Thermbond refractory repair commenced.

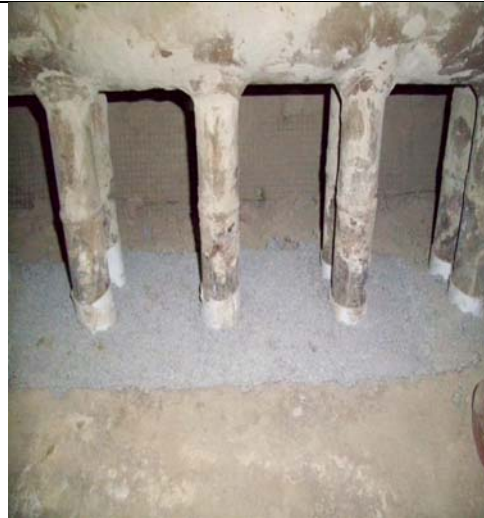
Completed area of Thermbond Formula 3L castable repair showing the thermal insulation paper wrapped around the tubes.

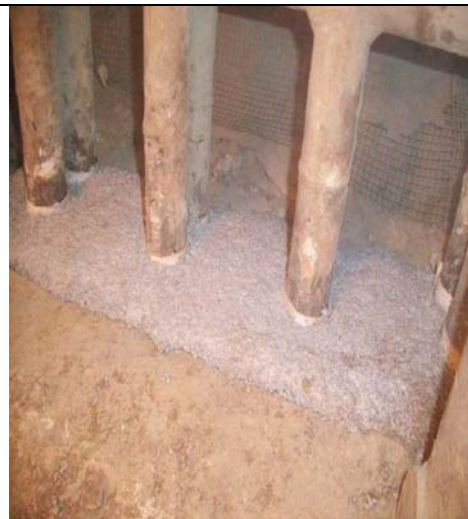
Completed area of Thermbond Formula 3L castable repair, there were 137 tubes repaired on this outage and the remainder would be done on the next outage.

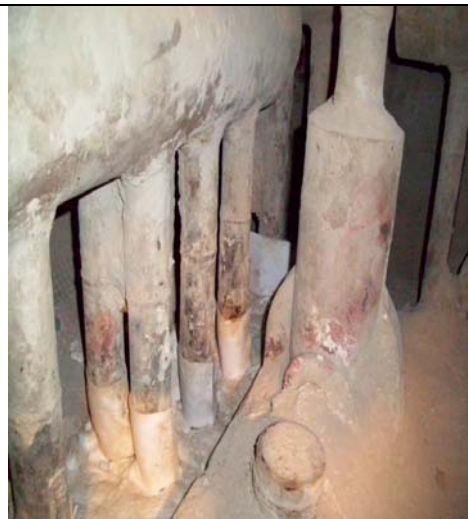
Prepared tube penetration with 2mm thermal insulation paper adhered to the tubes with Maxigrip adhesive (rated 1000degC) for expansion allowance. Bio-soluble blanket layed down to prevent loss of refractory material through the Penthouse floor
