## REFRACTECH THERMBOND REPAIR REPORT AT LOY YANG POWER

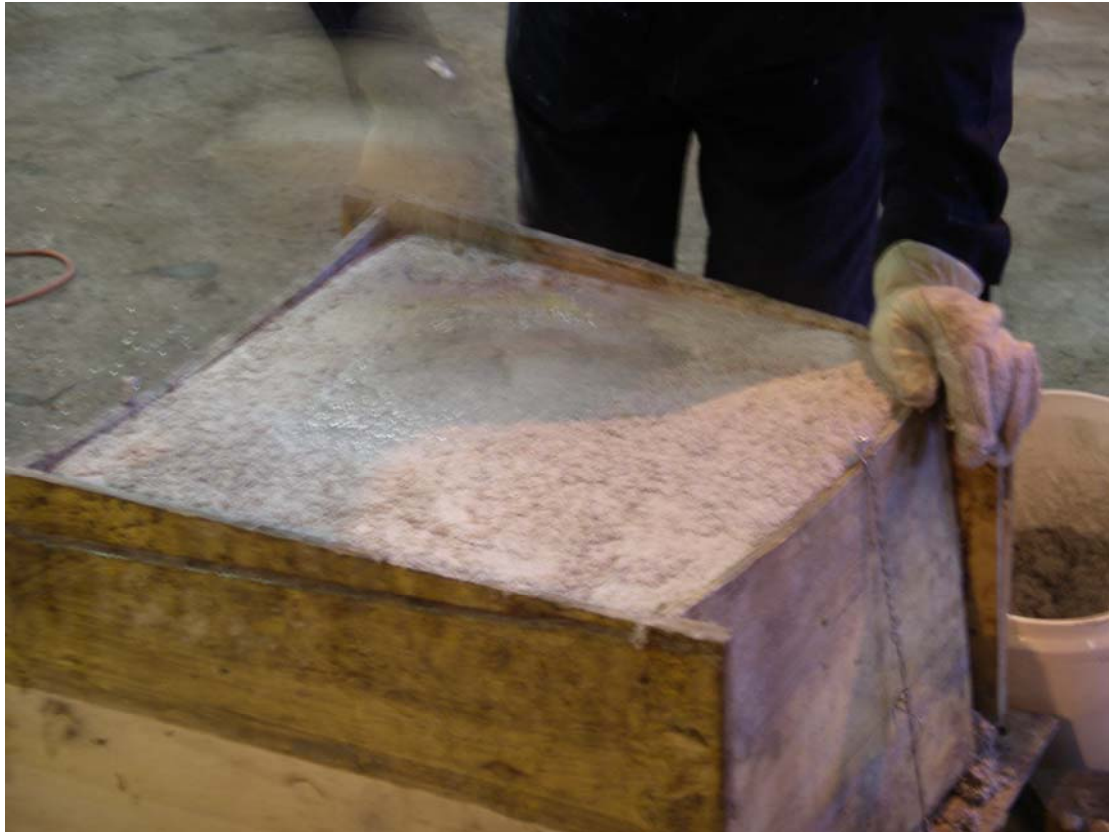
November 2006: Thermbond chemical bond castable precast boiler door block. Andreco cast Thermbond Formula 6L door block into timber mould.

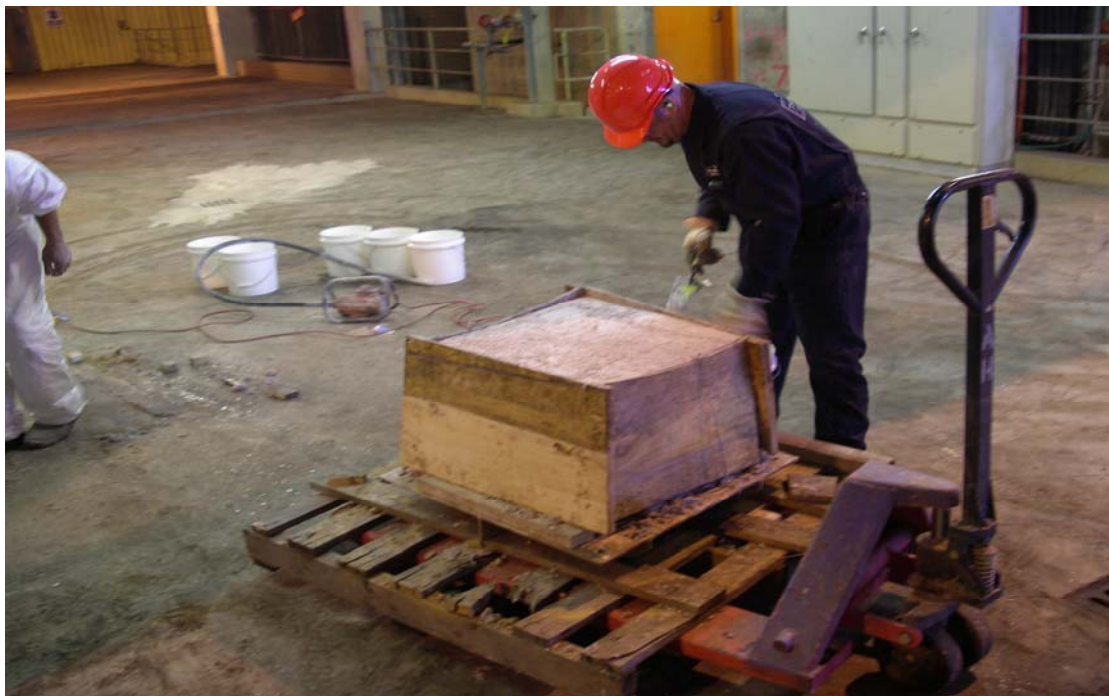
November 2006: Thermbond Formula 6L precast door block for boiler furnace.

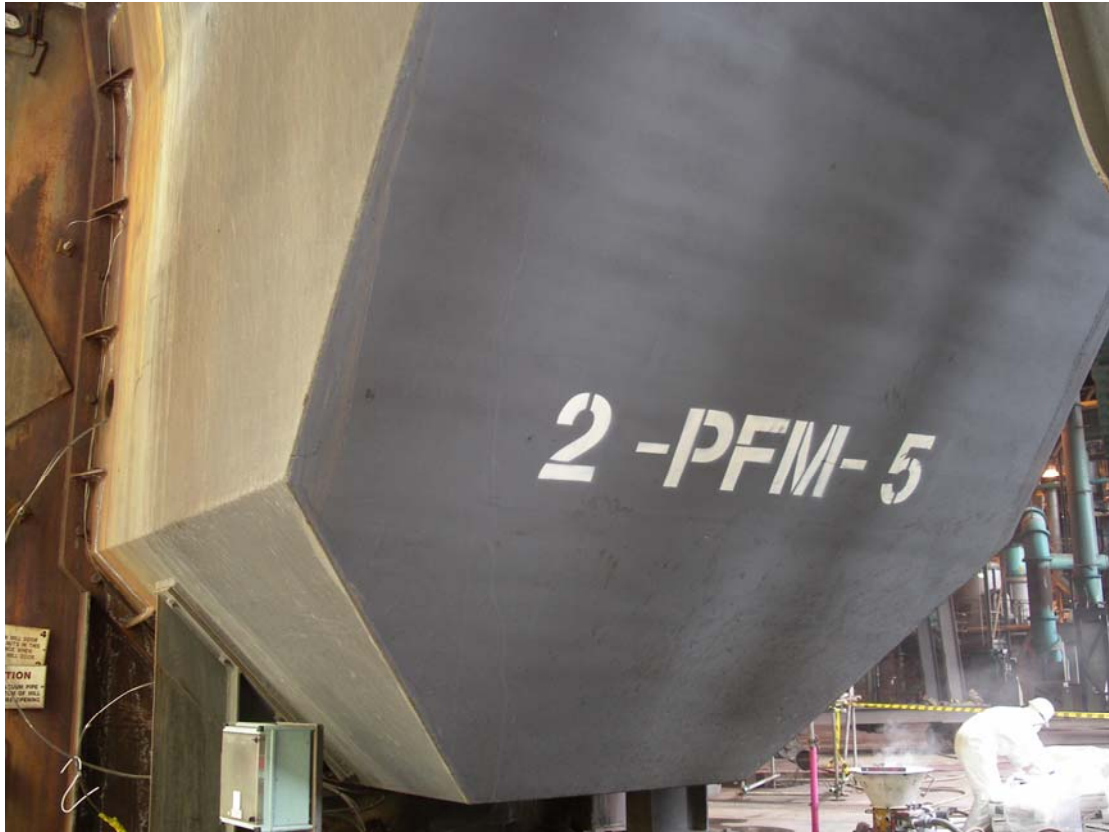
November 2006: Loy Yang Power Mill door Thermbond gunning repairs.  
Thermbond Formula 6AG gunning castable installed to repair fired refractory.

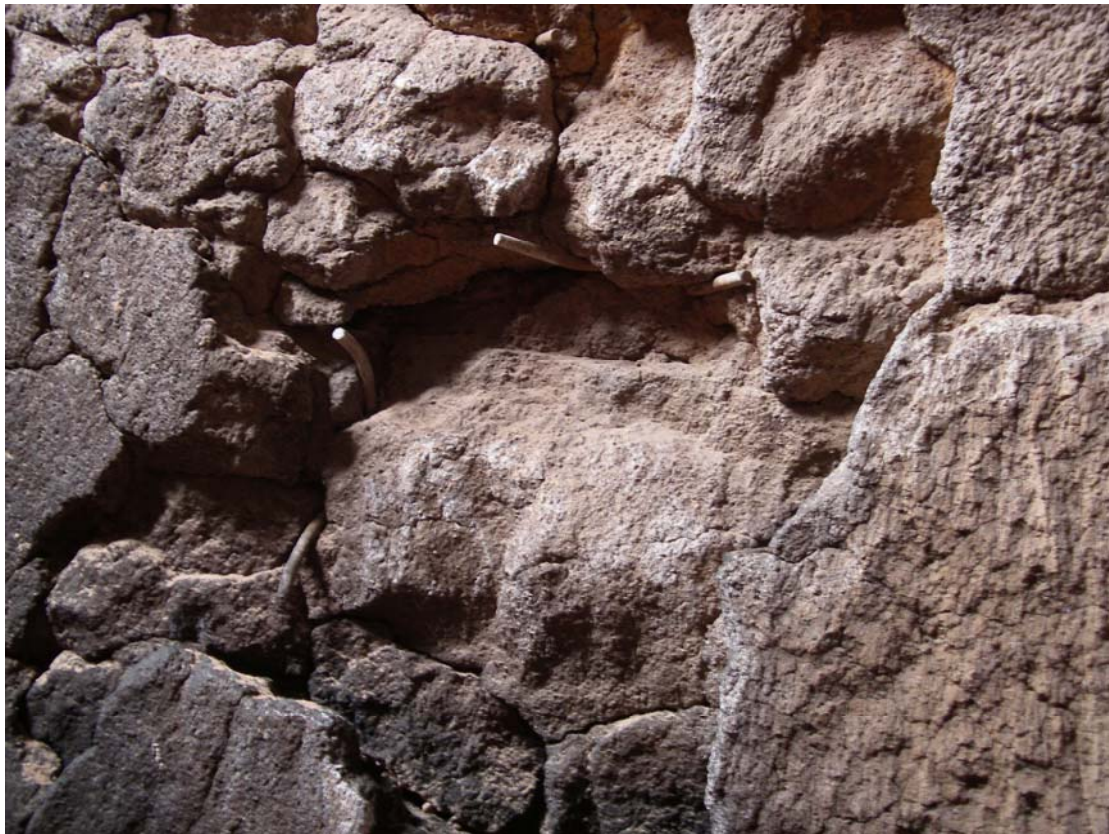
November 2006: Condition of Loy Yang Power mill door fired refractory **before**  
Thermbond F6AG castable gunned onto mill door fired refractory.

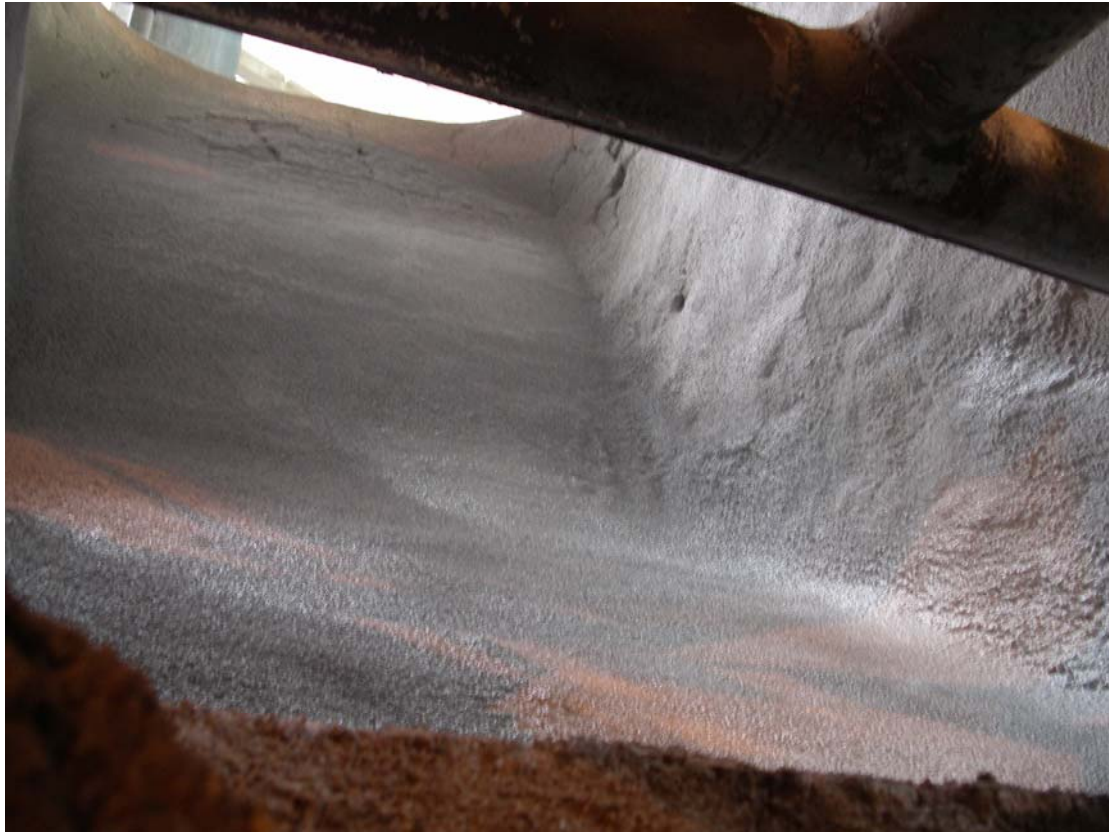
November 2006: Result of spraying 48 bags Thermbond Formula 6AG gunning castable onto fired, cleaned refractory in Loy Yang Power 2-PFM-5 boiler mill door.

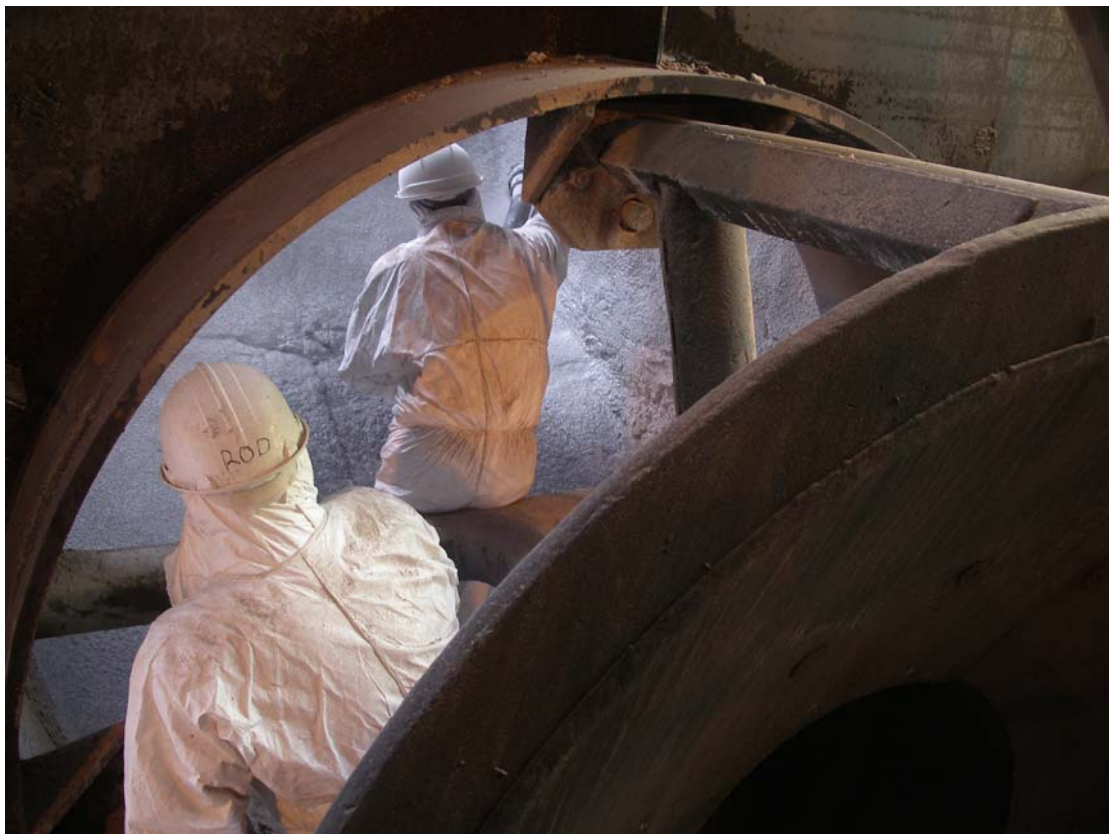
November 2006: Contractor Andreco Hurll spraying Thermbond Formula 6AG gunnite, showing low dust emission and minimal rebound during gunning operation.

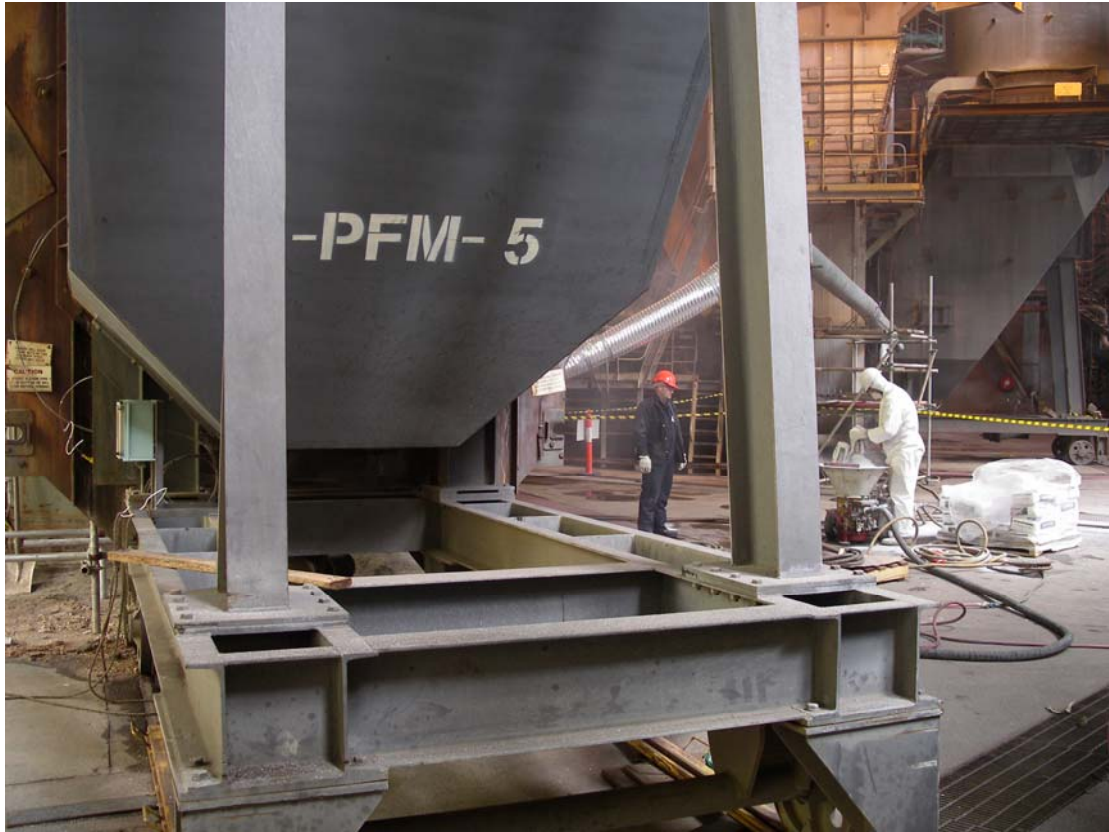
November 2006: Thermbond gunning repair operation at Loy Yang Power Mill door

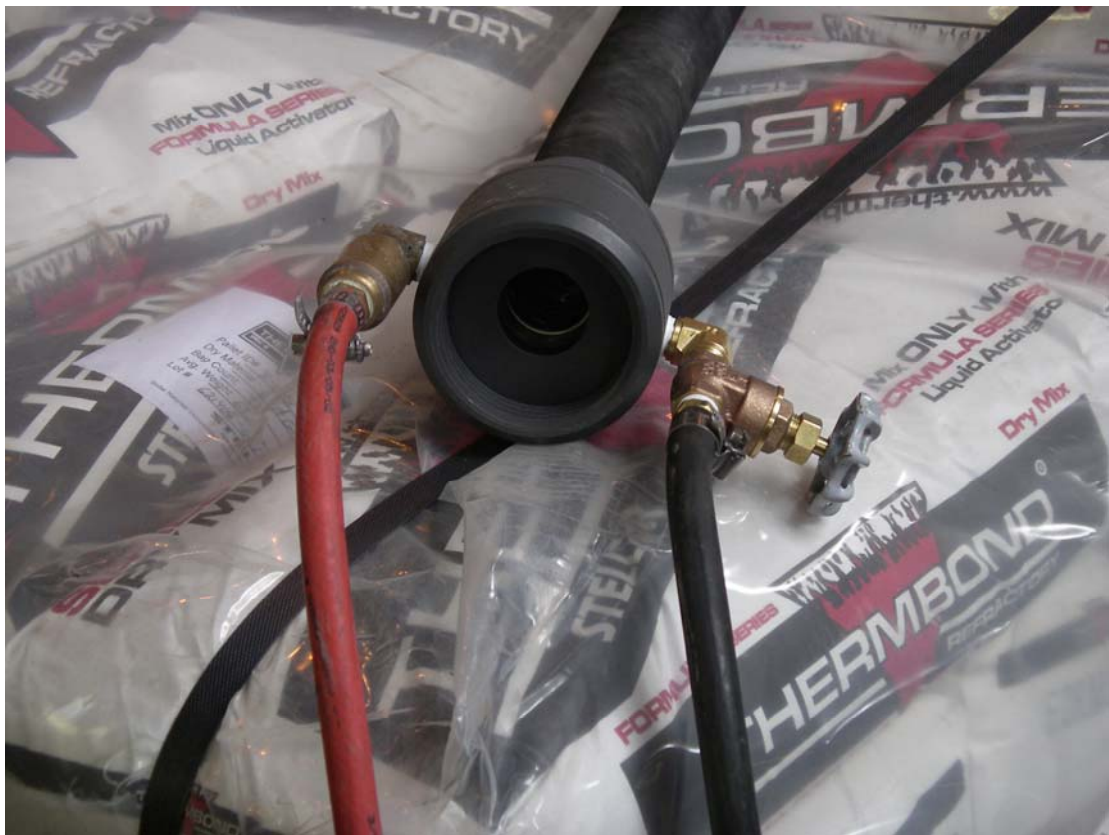
November 2006: Thermbond gunning nozzle assembly for Loy Yang gunning repairs.
